## Installation Instructions For 2012-2016 BMW F10/F11 520i 528i (N20)

### KIT CONTENTS

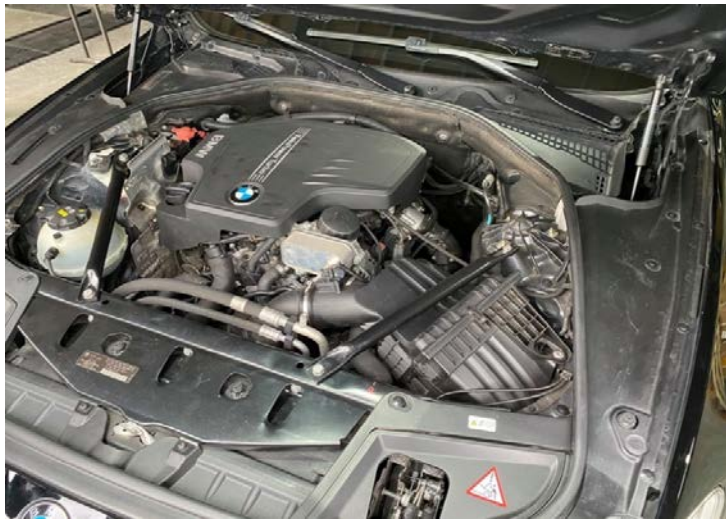
Figure 1: Stock air box. 原廠引擎室

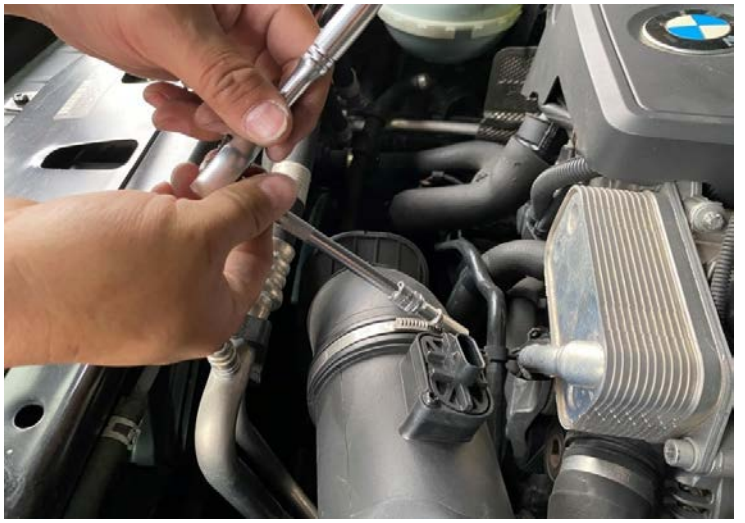
Figure 4: Loosen the stock tube clamp.  
鬆開原廠管夾

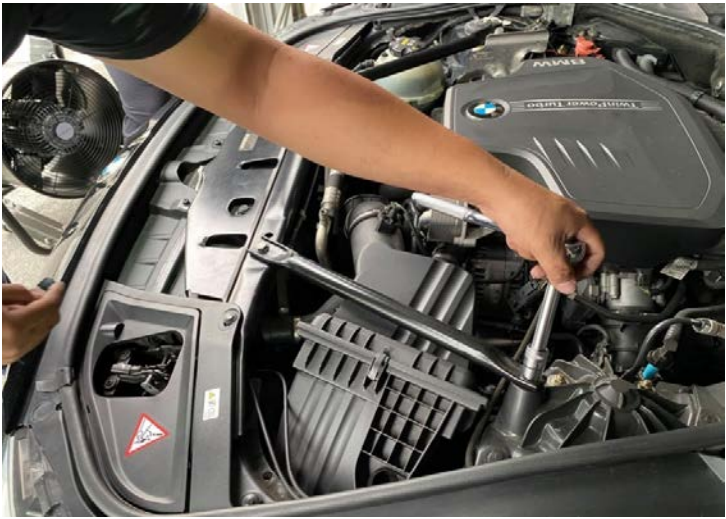
Figure 2: Remove the strut bar. 拆下支柱桿

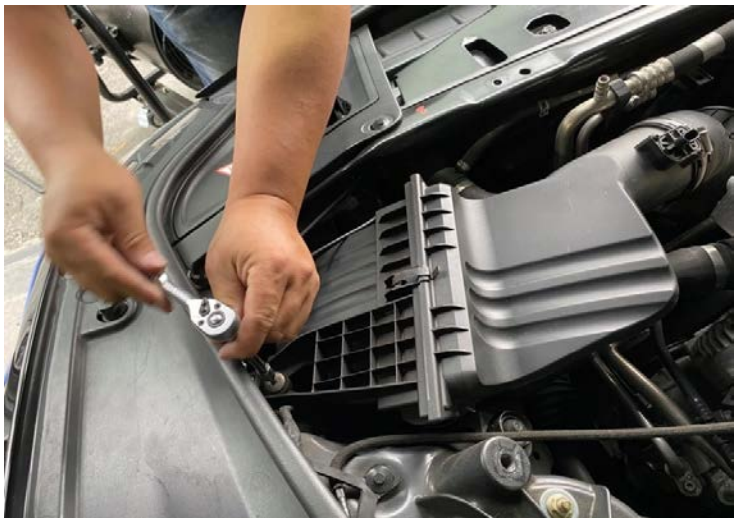
Figure 5: Remove the air box bolt.  
拆下集氣箱螺栓

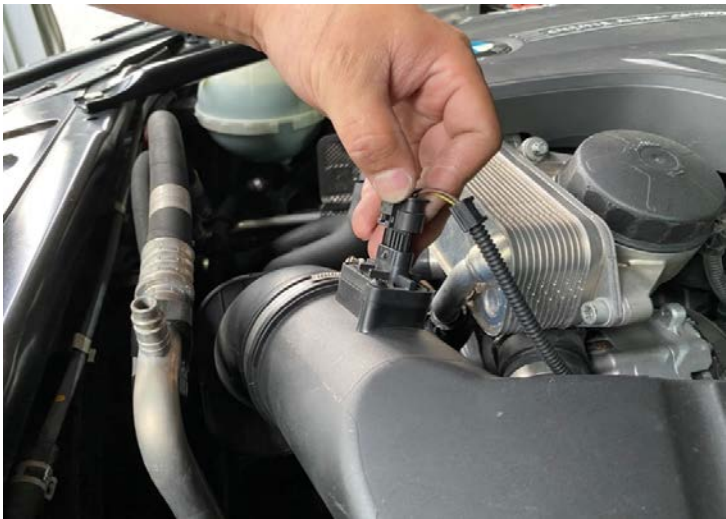
Figure 3: Disconnect the MAF sensor.  
斷開MAF感應器的連接

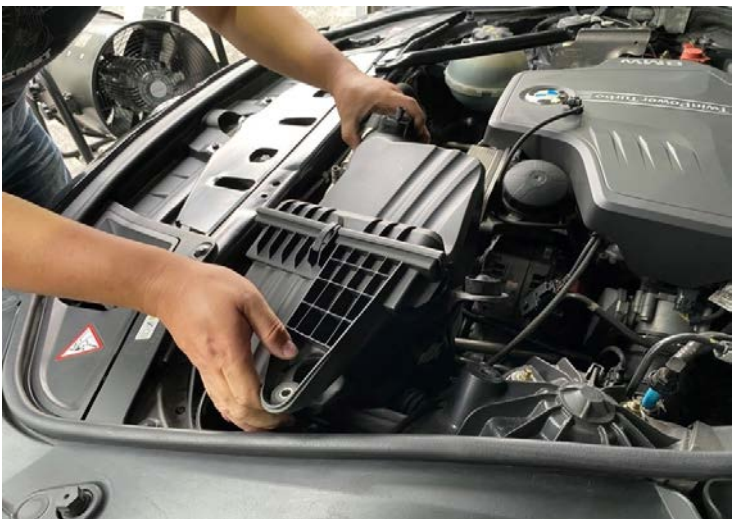
Figure 6: Remove the stock air box. 拆下原廠集氣箱

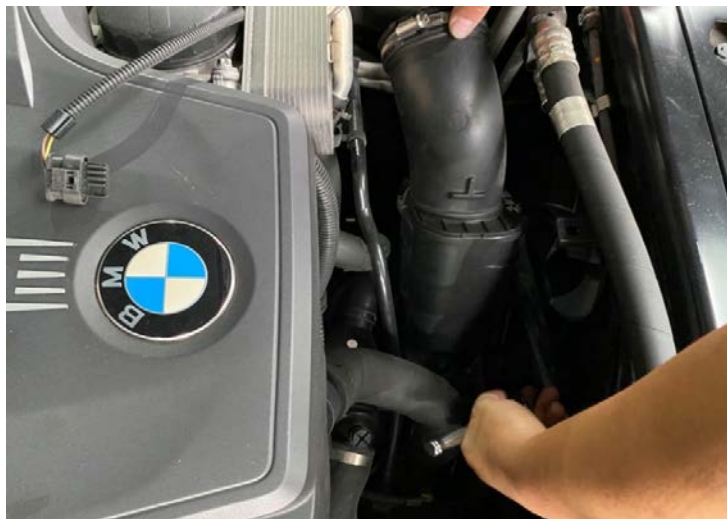
Figure 7: Remove the stock tube.拆下原廠管

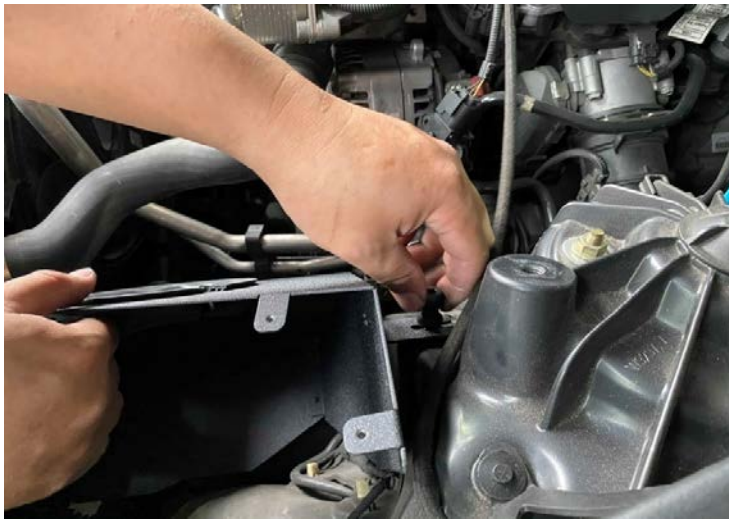
Figure 10: Tight the bolt.擰緊螺栓

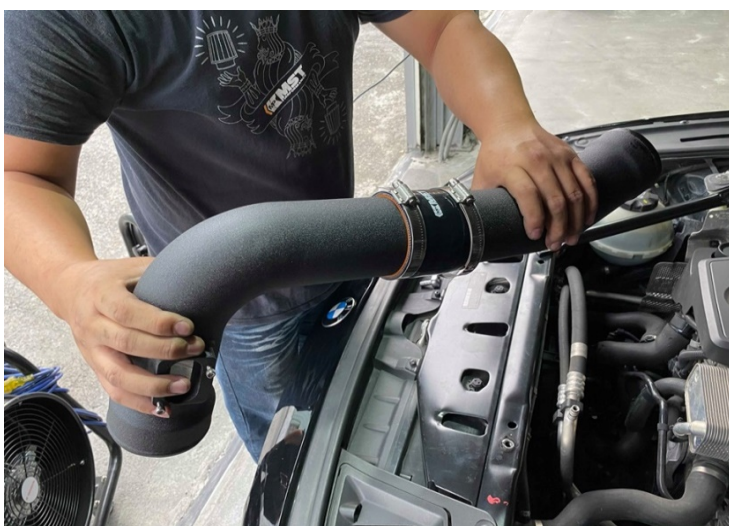
Figure 11: Install the intake pipe.安裝進水管

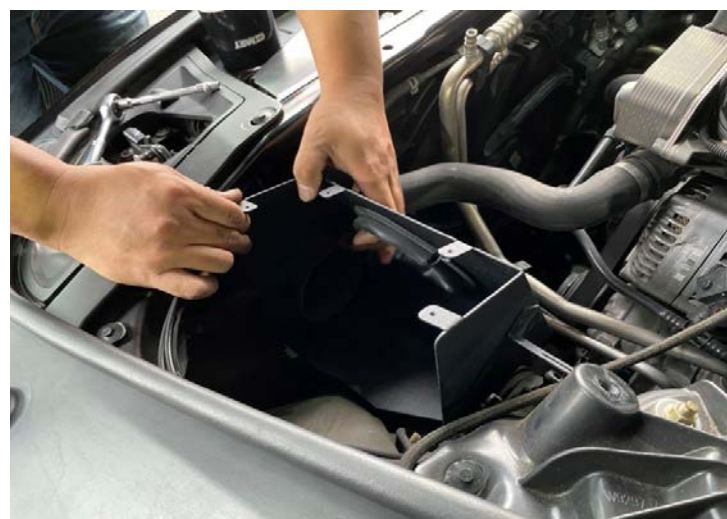
Figure 9: Install the heat shield.安裝隔熱罩

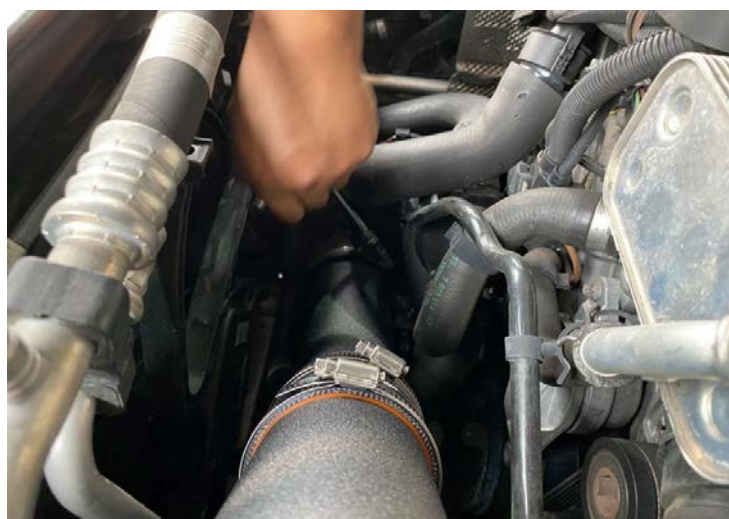
Figure 12: Tight the clamp.擰緊夾子

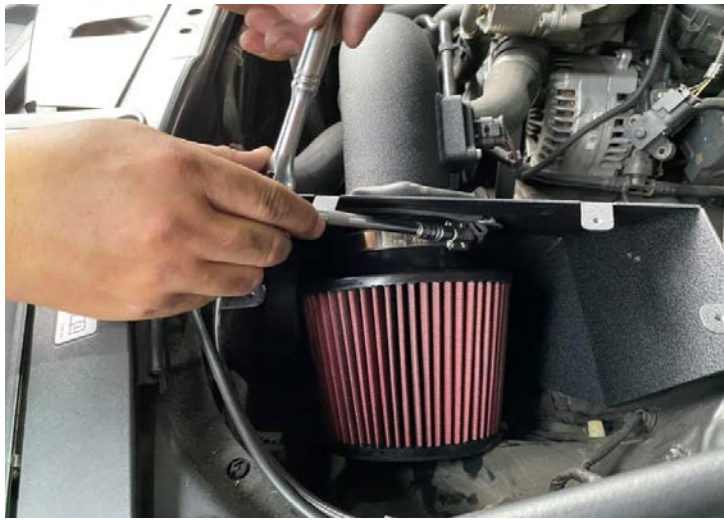
Figure 13: Install the air filter.安裝空氣過濾器

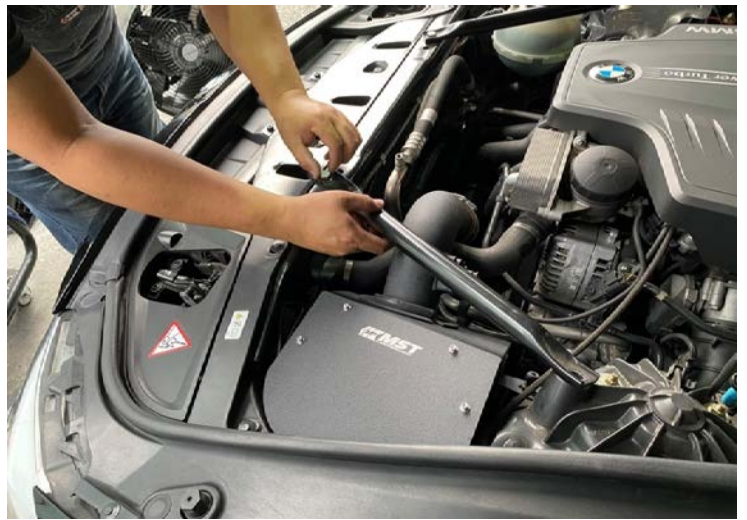
Figure 16: Install the strut bar.安裝支撐桿

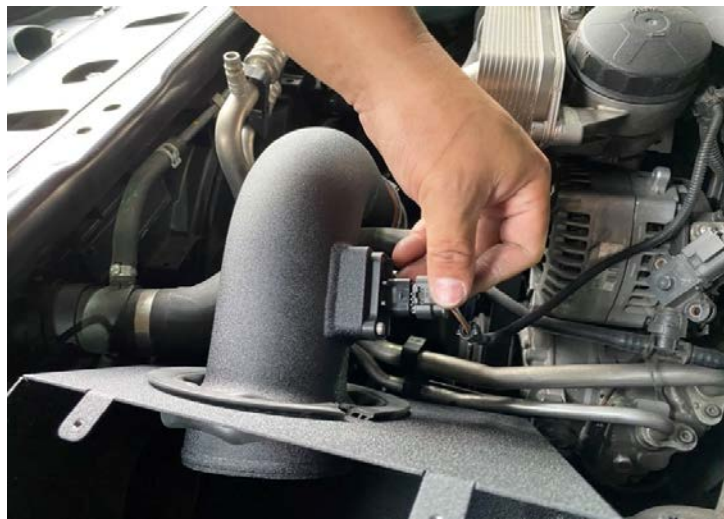
Figure 14: Connect the MAF sensor.連接MAF感應器

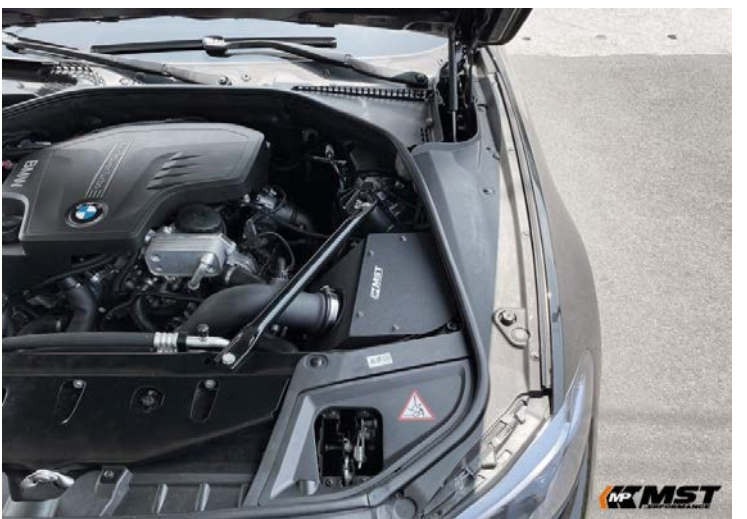
Figure 17: Congratulations! You have just completed the installation of this intake system. Periodically, check the alignment of the intake, normal wear and tear can cause nuts and bolts to come loose.

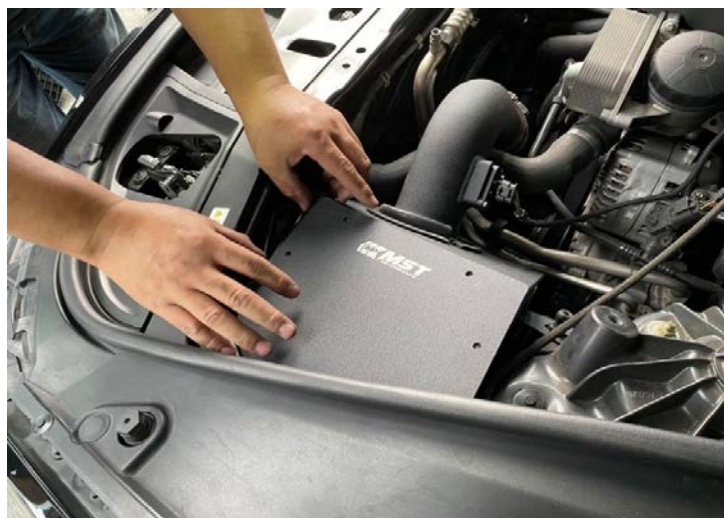
Figure 15: Install the heat shield cover.安裝隔熱罩
