Photovoltaic module Cleaning Robot Verification Test

Sample No:	--	
	Start date:	October 26, 2022	
	Finish date:	November 10, 2022	
	Standards used: (Date):	According client's requirement	
	Clauses examined:	Null	
	Re-testing:	Null	
Photovoltaic module Cleaning Robot <Model: Kwun-B30 >		Remark / Note:	Null
Test requirement:			
<ul style="list-style-type: none"> - Visual inspection Photovoltaic module. - EL testing of Photovoltaic module. 			
Test purpose:			
<ul style="list-style-type: none"> - To check if any AR glass defect of the PV module cleaned by Photovoltaic Module Cleaning robot after 2000 times, 4000 times, 6000 times, 8000 times, 10000 times, 12000 times, 14000 times cleaning. - To check if any cell micro crack defect of the PV module cleaned by Photovoltaic Module Cleaning robot.

TEST REPORT No.: BV2210WDG0169

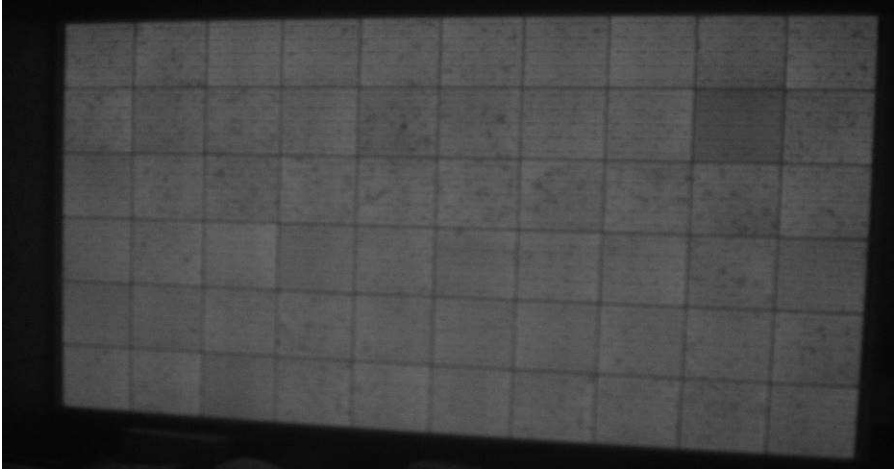
TABLE: Electroluminescence measurement (EL micro crack test) (After 2000 times cleaning)	
Test Date [MM/DD/YYYY]:	10/28/2022
Current applied [A].....:	10.0
Exposure [s]	3
Sample No.	Result
1	No cell micro crack
2	No cell micro crack
3	No cell micro crack

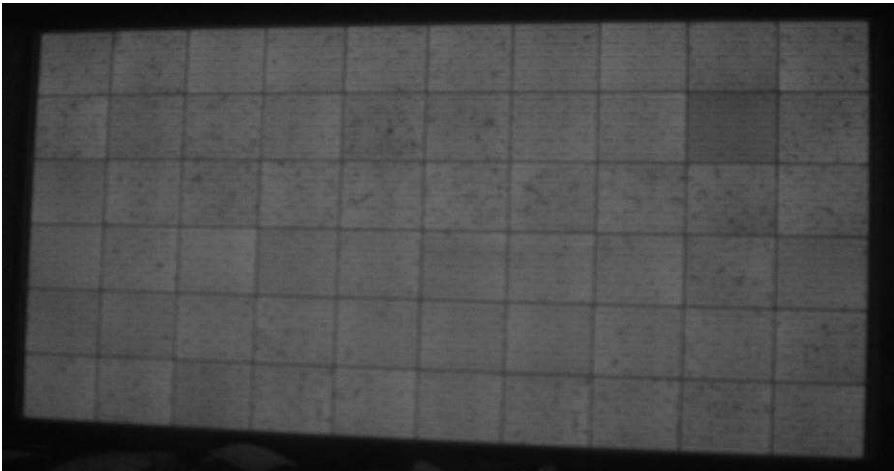
EL Picture		
Sample #	Status	Picture
Note		N/A
1	4000 times

TABLE: Electroluminescence measurement (EL micro crack test) (After 4000 times cleaning)	
Test Date [MM/DD/YYYY]:	10/31/2022
Current applied [A].....:	10.0
Exposure [s]	3
Sample No.	Result
1	No cell micro crack
2	No cell micro crack
3	No cell micro crack

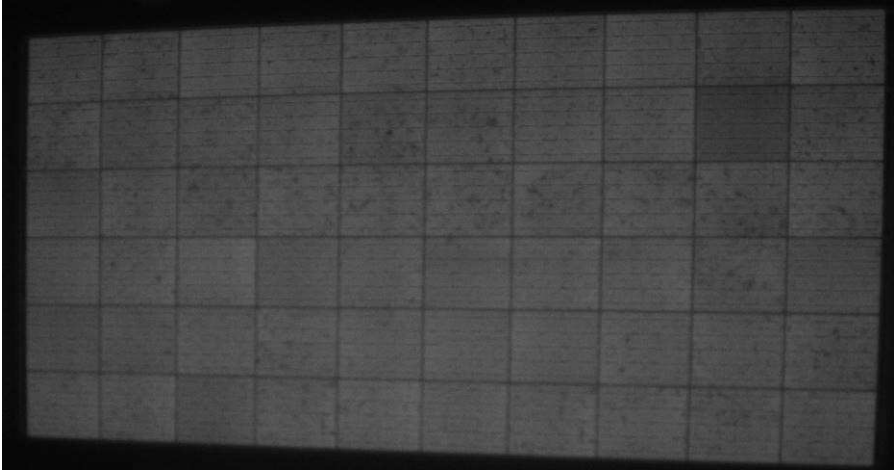
TABLE: Electroluminescence measurement (EL micro crack test) (After 6000 times cleaning)	
Test Date [MM/DD/YYYY]:	11/2/2022
Current applied [A].....:	10.0
Exposure [s]	3
Sample No.	Result
1	No cell micro crack
2	No cell micro crack
3	No cell micro crack

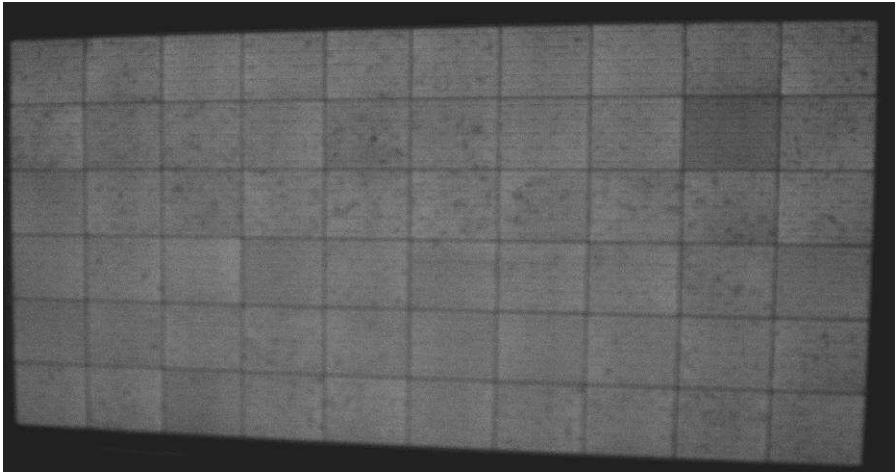
EL Picture		
Sample #	Status	Picture
Note		N/A
1	8000 times

TABLE: Electroluminescence measurement (EL micro crack test) (After 8000 times cleaning)	
Test Date [MM/DD/YYYY]:	11/4/2022
Current applied [A].....:	10.0

Exposure [s]	3
Sample No.	Result
1	No cell micro crack
2	No cell micro crack
3	No cell micro crack

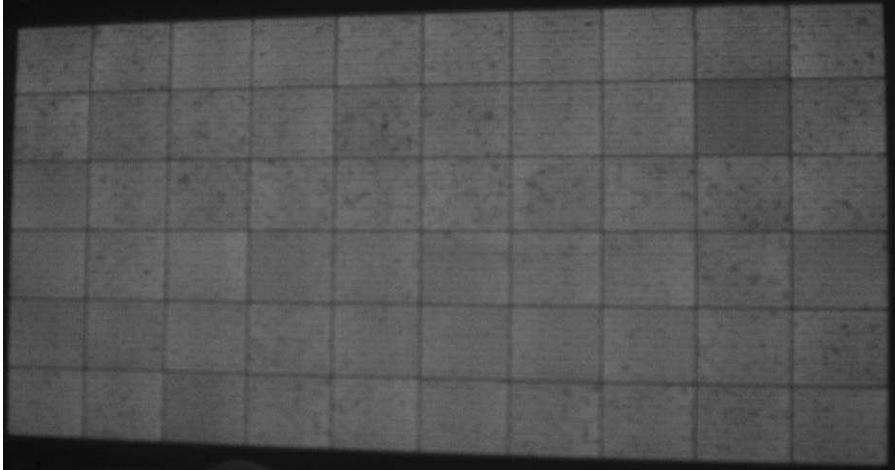
TABLE: Electroluminescence measurement (EL micro crack test) (After 10000 times cleaning)	
Test Date [MM/DD/YYYY]:	11/6/2022
Current applied [A].....	10.0
Exposure [s]	3
Sample No.	Result
1	No cell micro crack
2	No cell micro crack
3	No cell micro crack

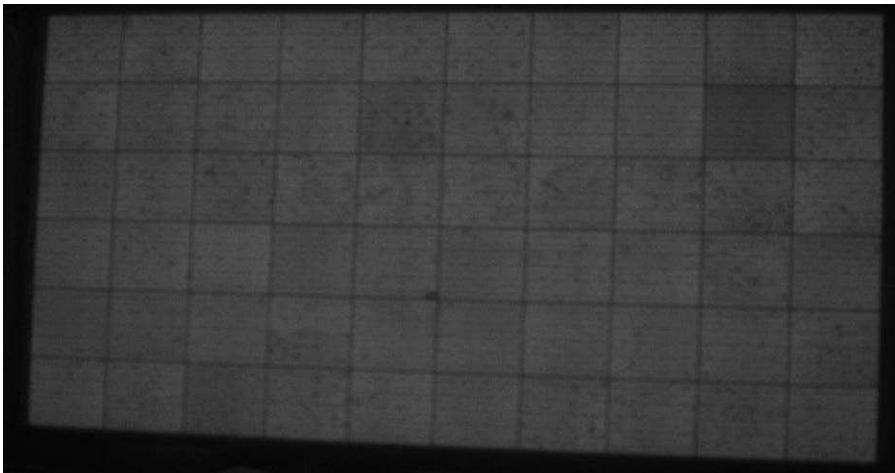
1	12000 times

TABLE: Electroluminescence measurement (EL micro crack test) (After 12000 times cleaning)	
Test Date [MM/DD/YYYY]:	11/8/2022
Current applied [A].....	10.0
Exposure [s]	3
Sample No.	Result
1	Cell occur micro crack.
2	Cell occur micro crack.
3	Cell occur micro crack.

After 14000 times cleaned by Photovoltaic Module Cleaning robot, no AR glass visual defect; no cell micro crack after 10000 times, but the cell occur micro crack after 12000 times.

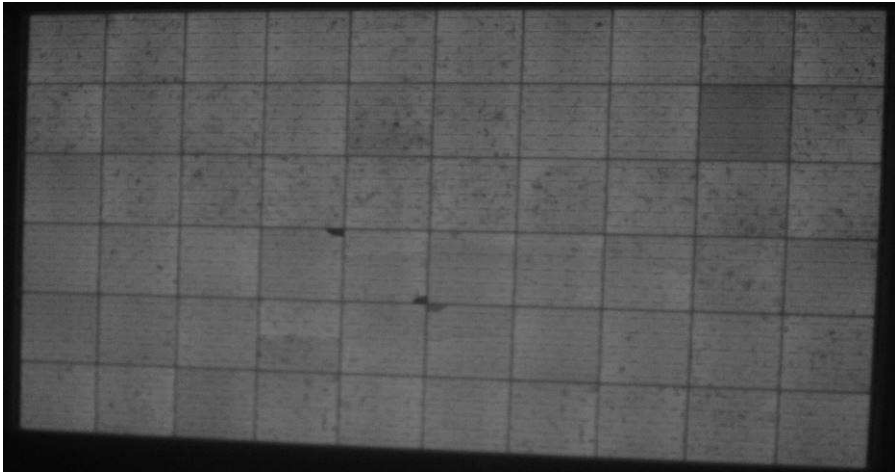
TABLE: Electroluminescence measurement (EL micro crack test) (After 14000 times cleaning)	
Test Date [MM/DD/YYYY]:	11/10/2022
Current applied [A].....	10.0
Exposure [s]	3
Sample No.	Result
1	Cell occur micro crack.
2	Cell occur micro crack.
3	Cell occur micro crack.
